Single Event Effects and Their Mitigation at the Collider Detector at Fermilab

R.J. Tesarek Fermilab

Single Event Effects at CDF

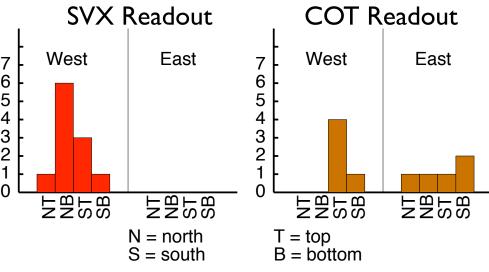
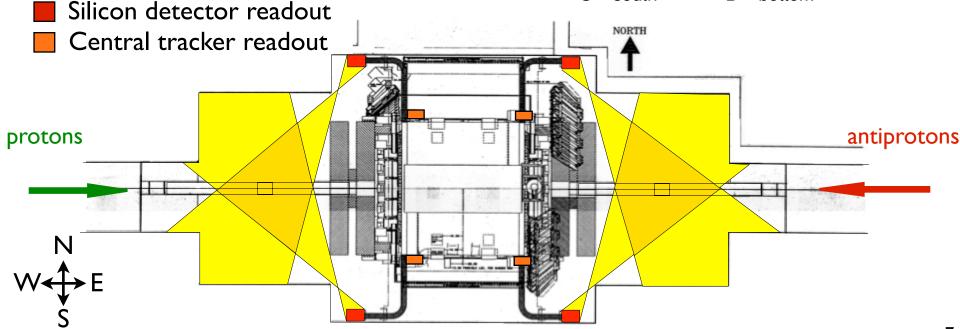
Failure Locations

Failure Characteristics

- Position Dependent
- Beam Related

Experiments show focusing quads are a line source of radiation

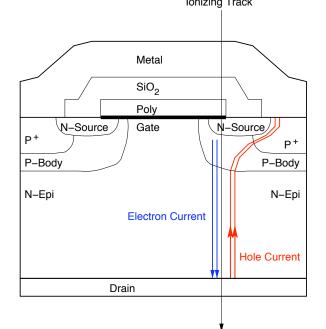
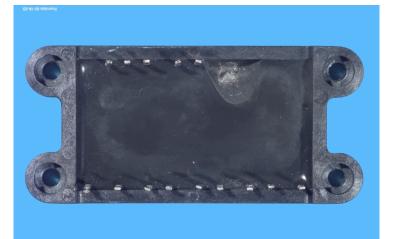
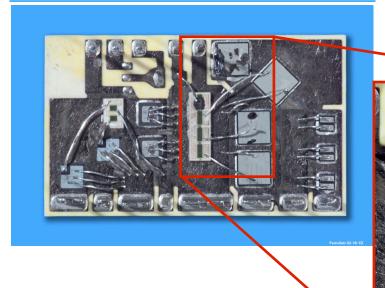
Most failures were associated with high beam losses or misaligned beam pipe

Power MOSFET SEB (radiation induced) lonizing Track

epoxy covering fractured

silicon in MOSFET sublimated during discharge through single component

Solution (lower Vbias)

- Factor of 50 reduction in radiation sensitivity
- No failures in > 2 years operation

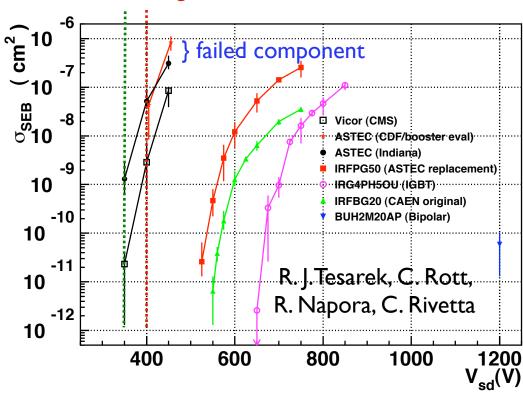
SEB cross section measurement

- catastrophic
- beam related
- damage at low doses
- depends on bias voltage

Test beam data, 200 MeV protons Indiana Cyclotron
