Single Event Effects and Their Mitigation at the Collider Detector at Fermilab

R.J. Tesarek Fermilab

Single Event Effects at CDF

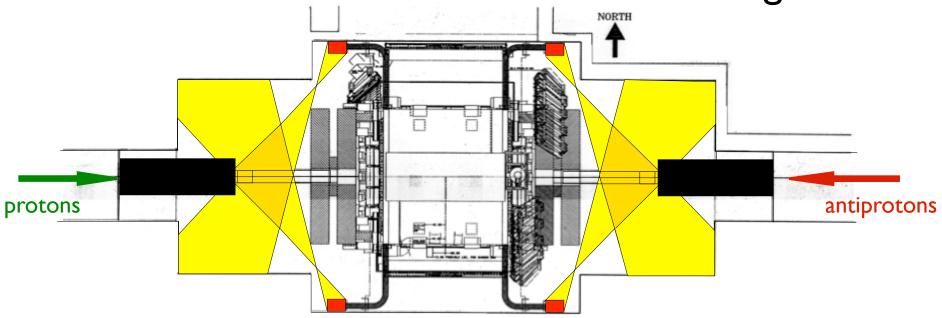
CDF Detector w/ additional shielding

Power supply failure analysis shows largest problem on the west (proton) side of the collision hall.

Shielding reduces ionizing radiation by 25%

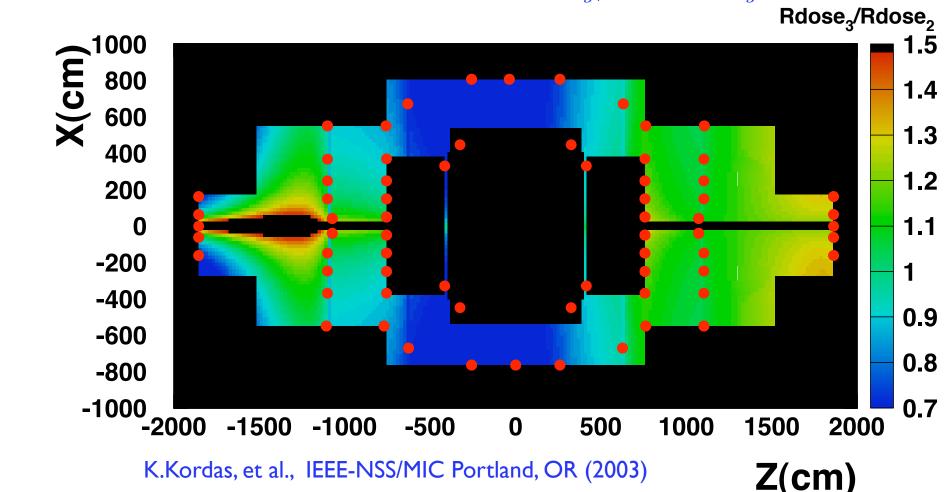
Collision Hall Ionizing Radiation Field

Thermal luminescent dosimeter (TLD) measurements Shielding installed on proton side only.

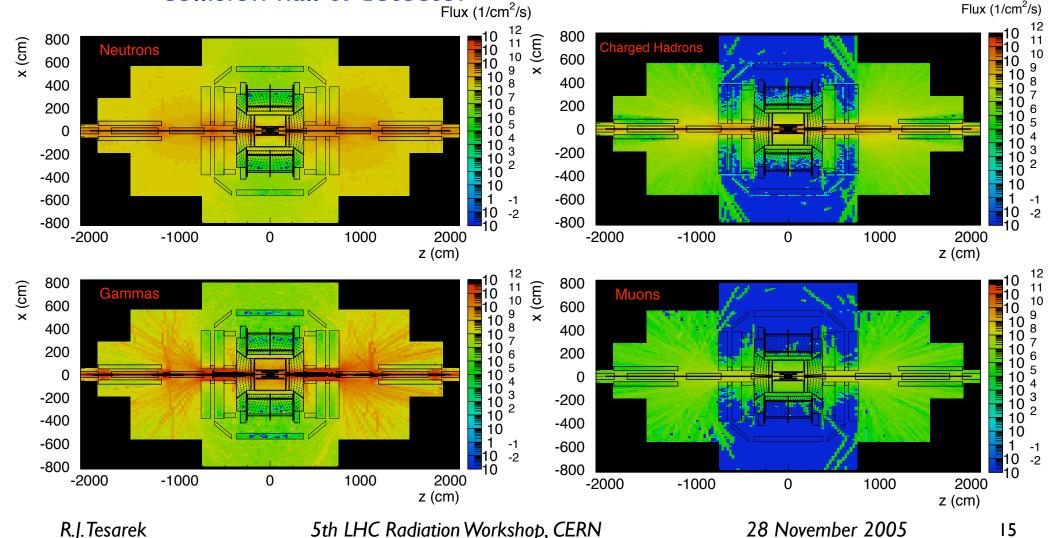
Simulated Radiation Environment Detailed MARS simulation of:

- accelerator & beam transport
- collision hall & detector

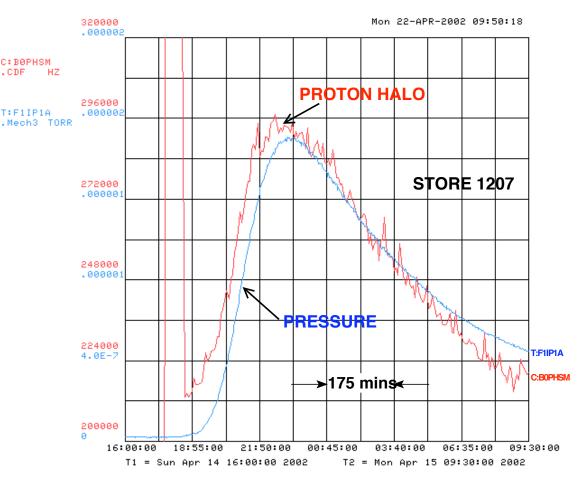
Halo (Beam Loss) Reduction

- > Halo/proton reduced by factor of 10.
- > Physics backgrounds reduced by ~40% in some triggers

Requires good beam quality monitoring

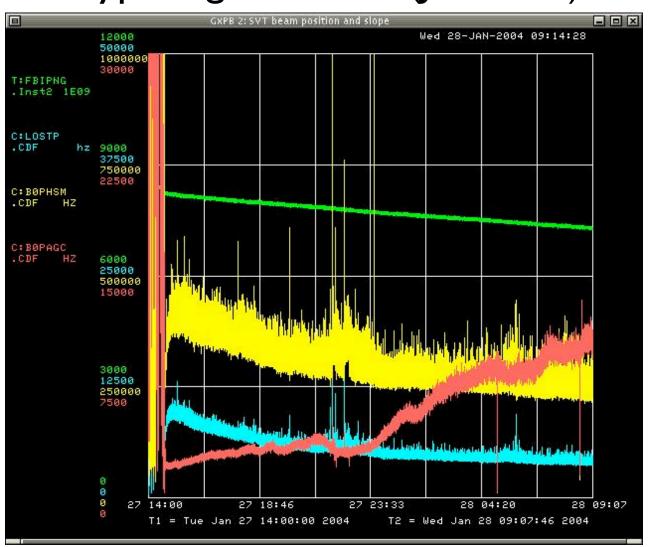
"Typical good store (Jan 2004)"

proton beam current

proton abort gap proton halo

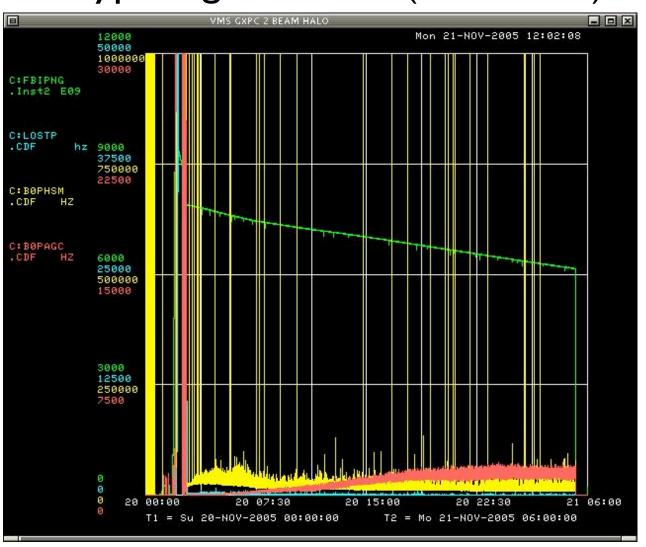
"Typical good store (Nov. 2005)"

NOTE: "spikes" in proton halo are a readout artifact

proton beam current
