INNOVATIVE DETECTORS FOR SUPERCOLLIDERS

ERICE-SICILY: 28 SEPTEMBER - 4 OCTOBER 2003

Radiation Damage and Long-term Aging in Gas Detectors

M. Titov,
Freiburg University / ITEP Moscow

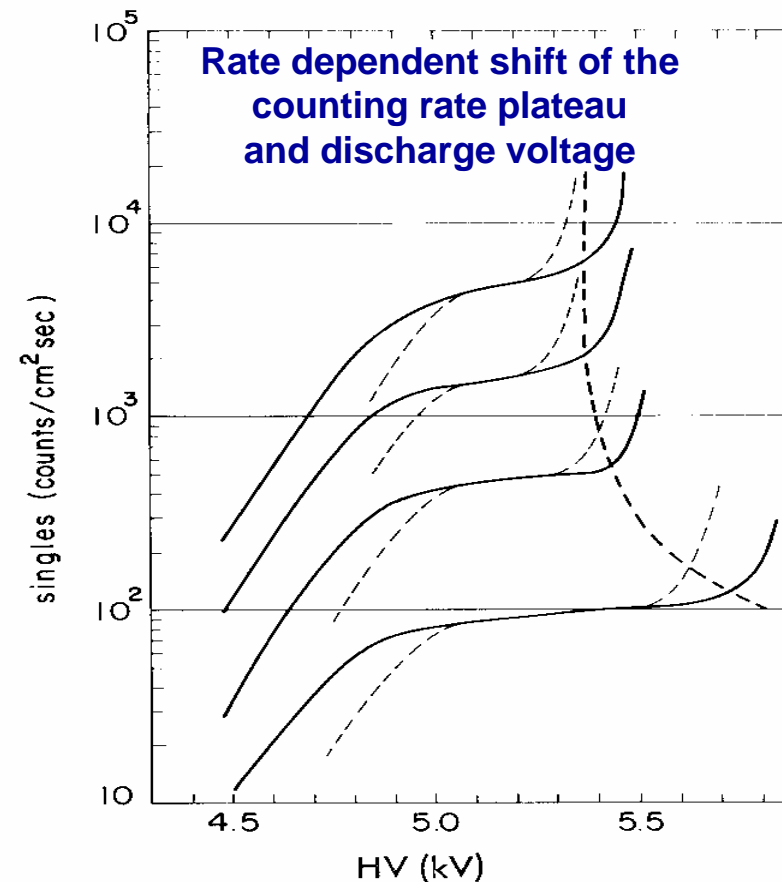
'Classical Aging Effects' lead to deposition of polymers on the anode (and/or) cathode surfaces and manifest as:

- Loss of gas gain and reduction of the plateau
- Loss of energy resolution
- Electron emission (Malter currents)
 - Sparking
- Self-sustained current discharge

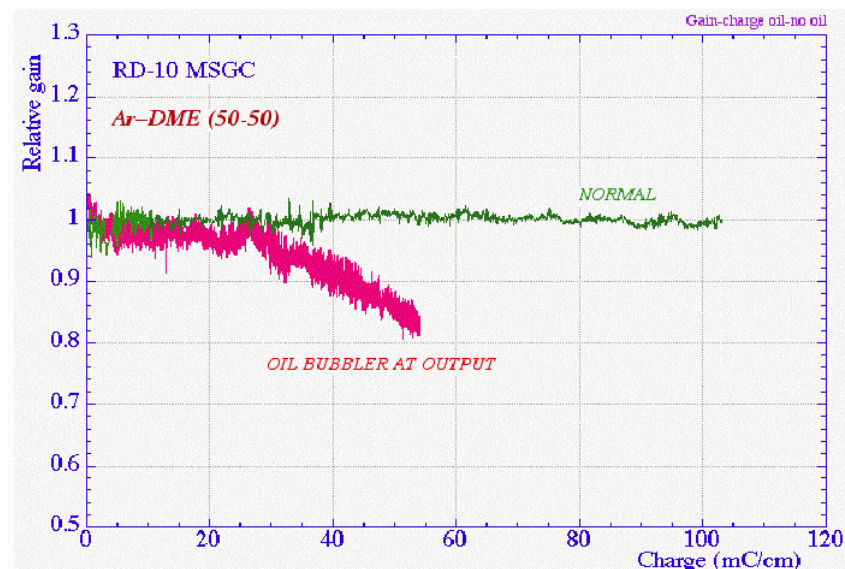
The silicon contamination is one of the most serious problem for wire chambers

Example: "Vogtlin" flow regulator (rotameter) specially produced by company and claimed to be free from any lubricants (particularly Si-based).

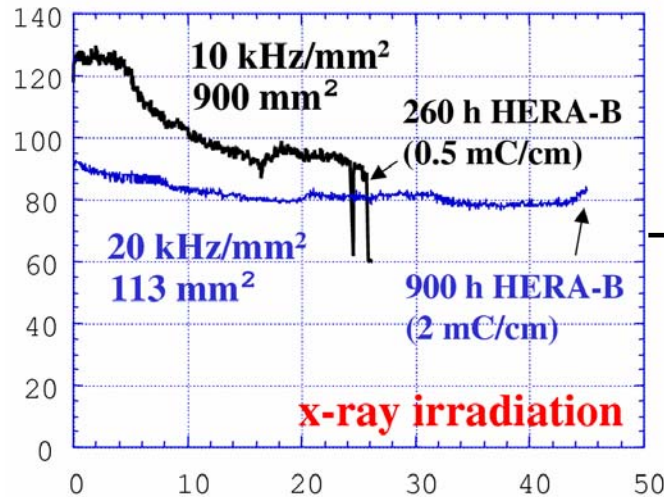
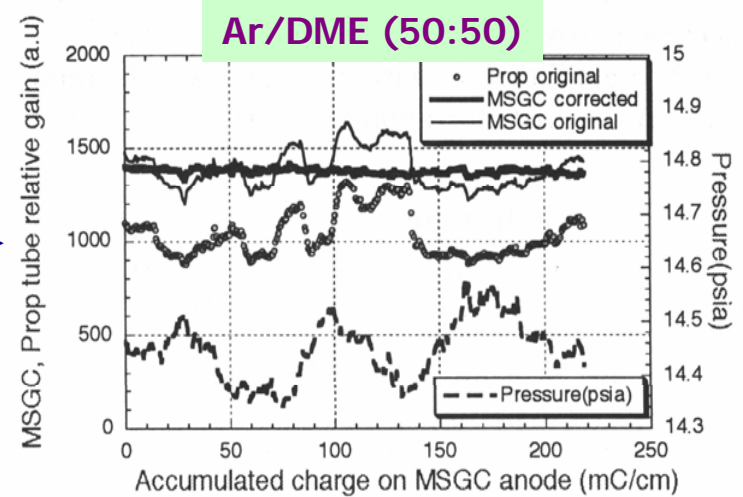
- Fast aging under X-rays, when size of the irradiated area is large enough (deposits are not limited to the irradiated area)
- Identical chambers with Ar/CO₂ showed no aging

Gas Aging Effects strongly depend on the size of the irradiated area

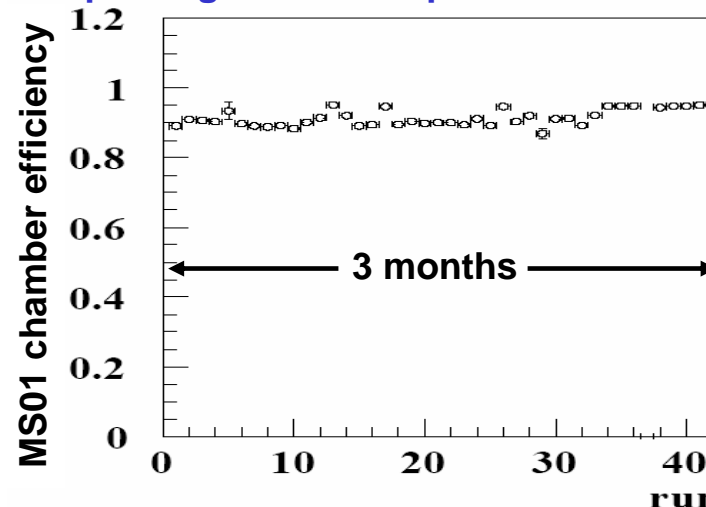
Reliable operation without major problems
Detector size: 25*25 cm²; Gas: Ar/CO₂(70:30)
Sparking rate: <~ 2 sparks/chamber/day

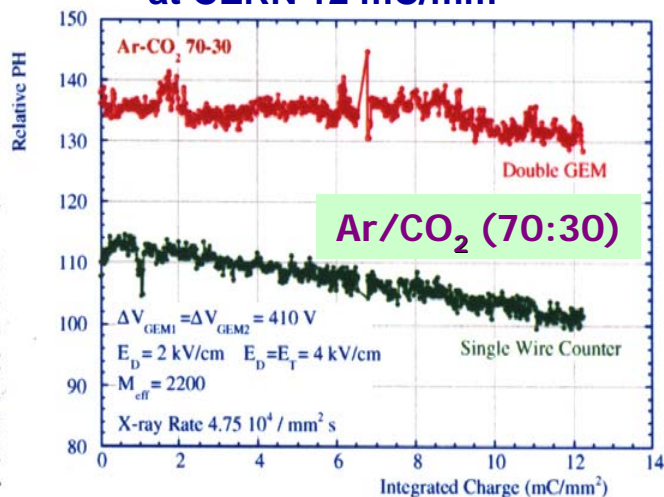
No gain loss in double GEM+PCB at CERN 12 mC/mm²

Fig. 3: Long-term gain stability under irradiation. A single-wire counter in the same gas line shows aging.

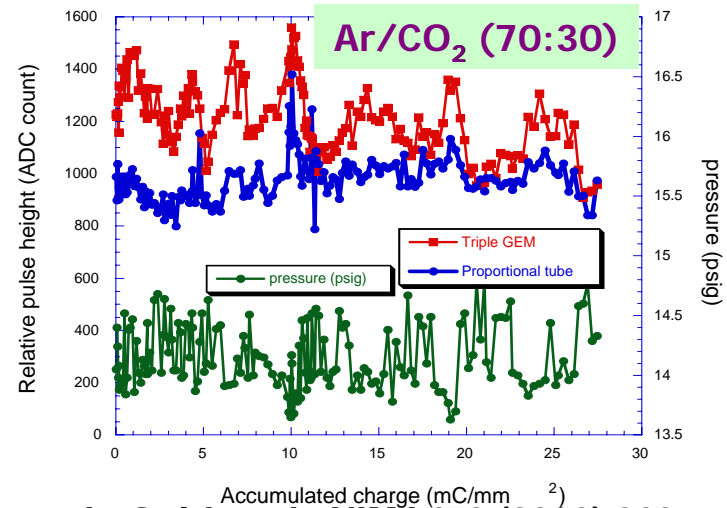
No visible aging effects in triple GEM+PCB at Purdue 27 mC/mm²

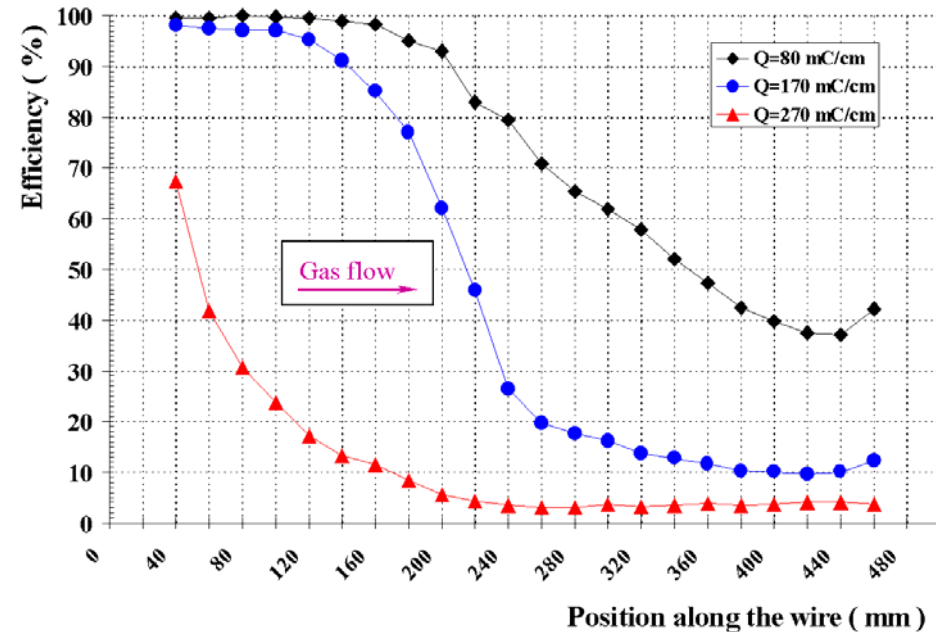
Progressive deterioration of performance in the direction of the serial gas flow

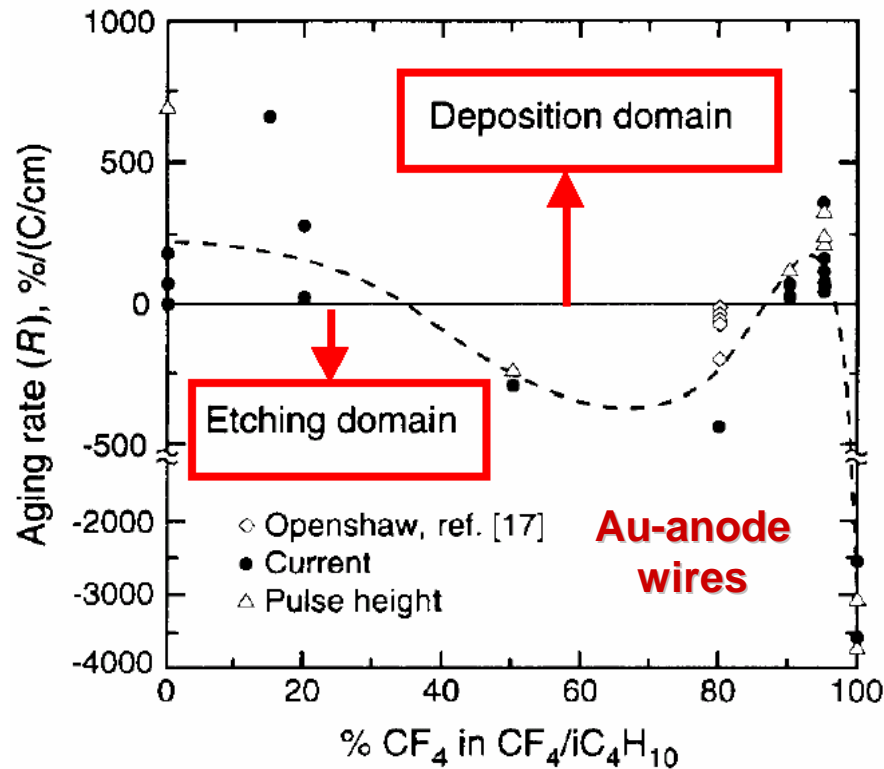
Laboratory wire chamber studies with CF₄/iC₄H₁₀: there appears 2 regions of polymerization and etching:

Heavy deposits are observed on the non-gold anode wires in all studied CF₄/iC₄H₁₀ mixtures regardless of whether or not that mixture lies in the etching region

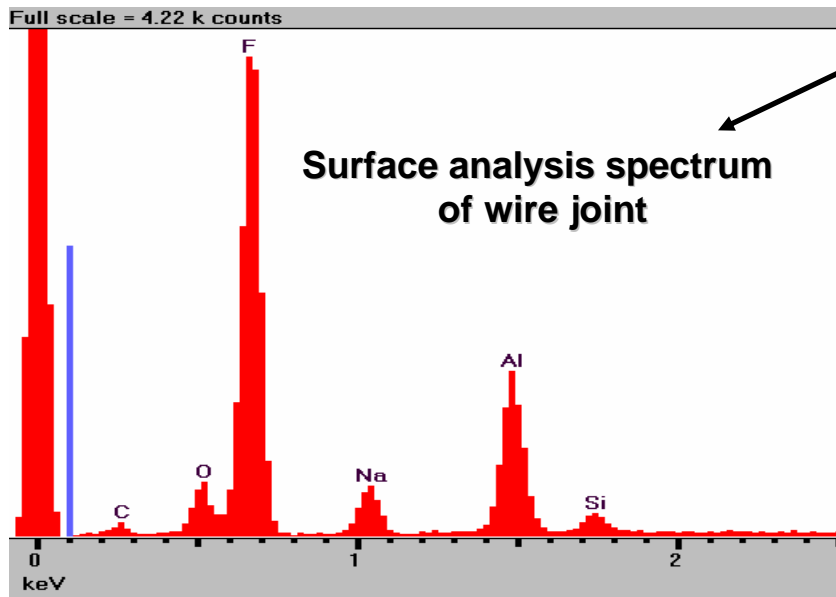
Etching of glass wires joints in Xe(Ar)/CF₄/CO₂ (70:20:10)

The ATLAS TRT glass wire joint separates electrically the barrel wire into two parts

- Much of the glass has been etched away and wire joints showed heavy cracks after irradiation in Xe(Ar)/CF₄/CO₂ at high dose rates
- No gain change due to Si etching from the glass wire joints (it seems that etched Si is in stable gas form and exits the system)
- Surface analysis of wire joints showed fluorine deposits while much of Si has disappeared

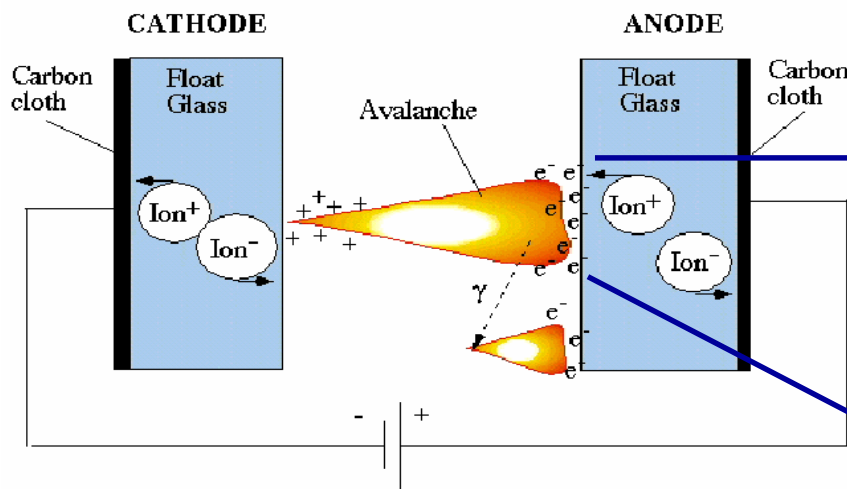
'98: High dark currents and efficiency drop were observed in glass RPC's:
(problem was due to ~ 2000 ppm of H₂O, permeating through the walls of plastic tubing)

This behavior was interpreted as a result of the HF acid production, which caused etching of the glass surfaces and created emission points, triggering chamber currents

A solution emerges: replace polyethetele tubing with copper ones (<10 ppm H₂O)
Good detector performance so far

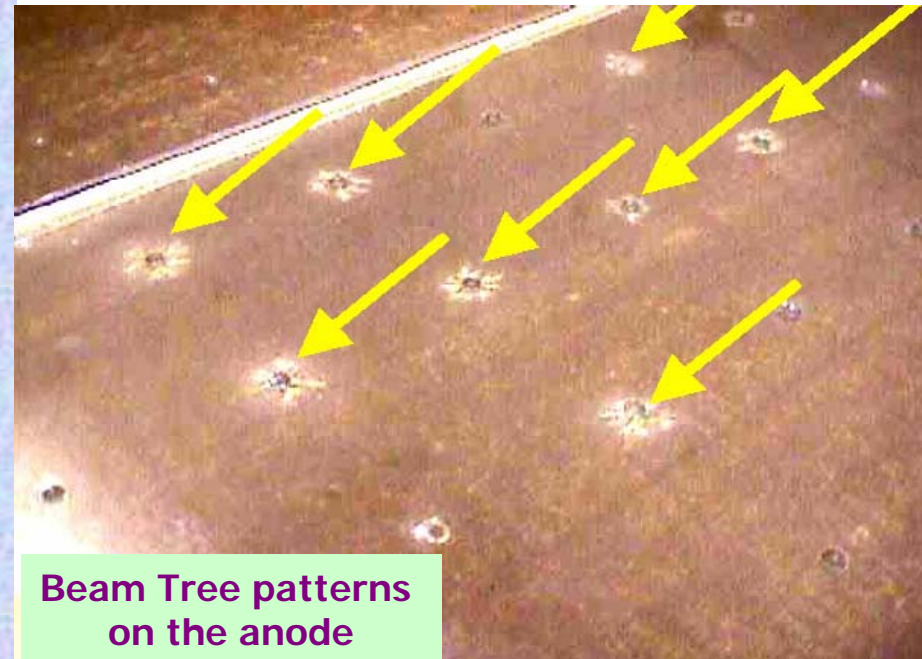
Beam Tree patterns on the anode

- Observe some degradation of efficiency;
- Beam tree pattern` on ~5% of the buttons on the anode; many sparking spots near the oil droplets at the cathode and along the chamber edges

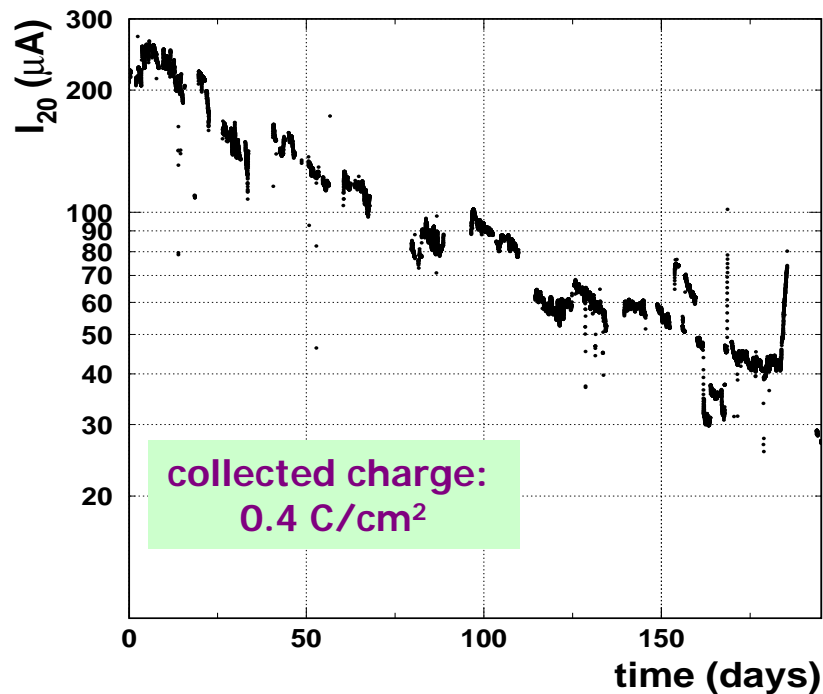
Irradiation at CERN GIF in 2001:
Steady exponential decrease of current by a factor of ~ 6

as a result of corresponding increase of the bakelite resistance due to the current flowing through the electrodes

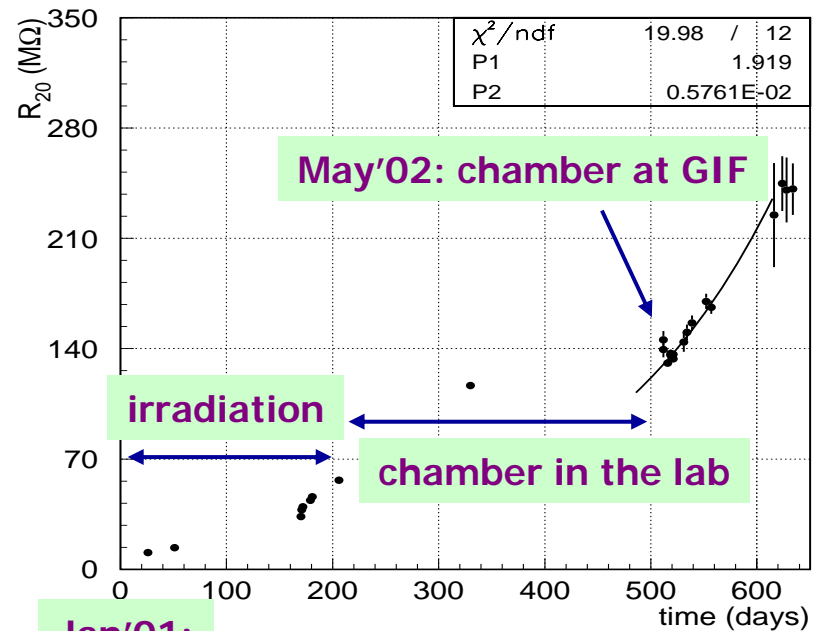
New aging tests in 2002:
Pure spontaneous aging is the dominant effect → could be related to the decrease of water content in bakelite

Rate capability dropped from a few kHz/cm² to less than 150 Hz/cm²
NO RPC in LHC-b

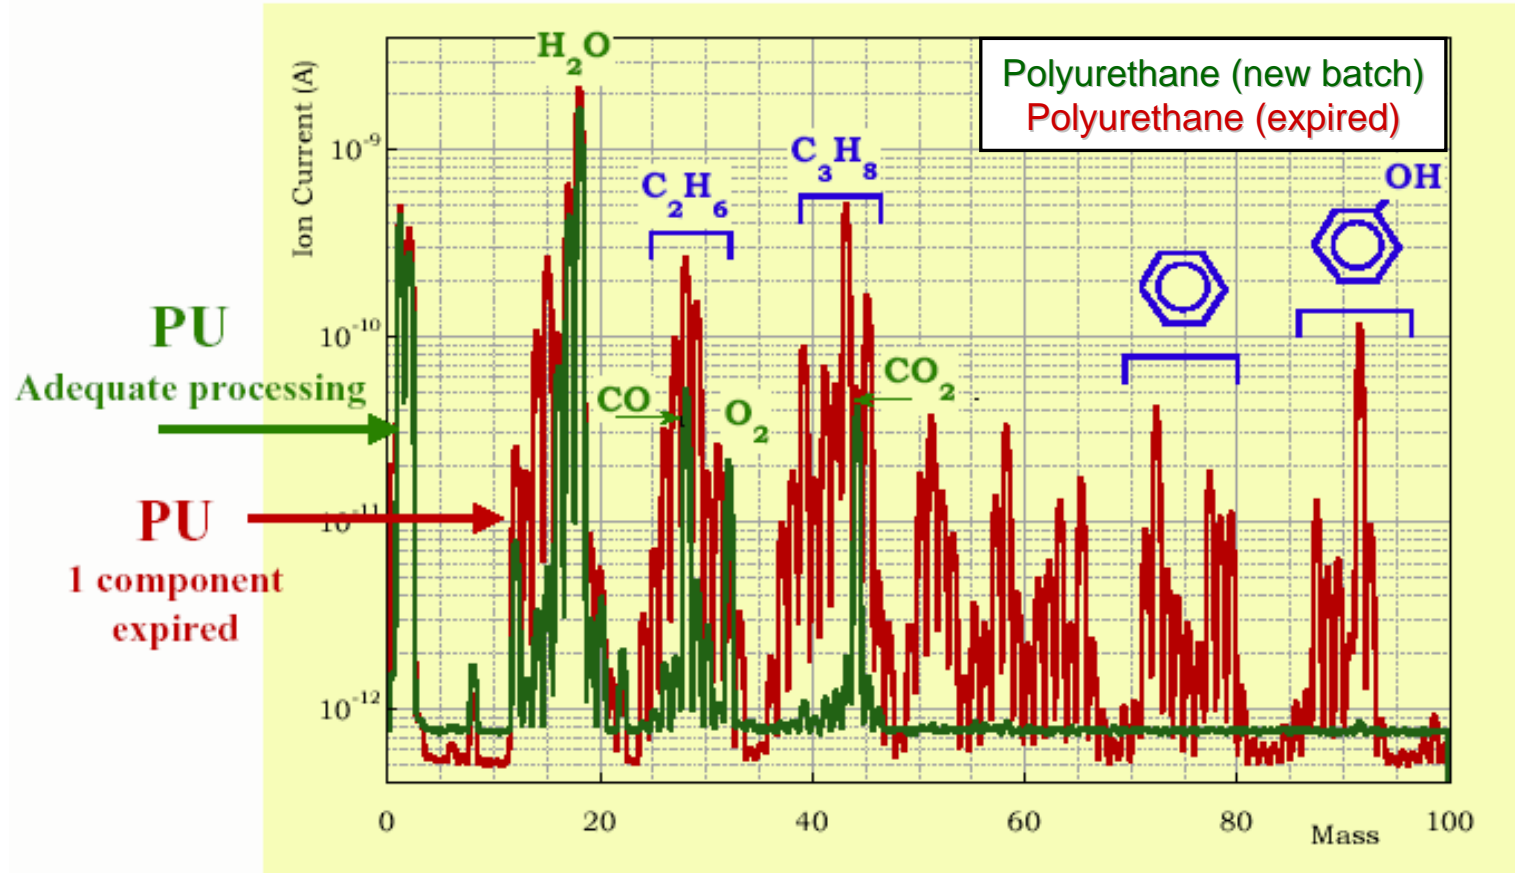
NEW vs EXPIRED: NUVOVERN LW -HARDNER PUR LW (Mader Lucke AG)
